Manhole Inspection Summary

Manhole # S23GG1022MH

Location Address: **4139 BUENA VISTA AVE**

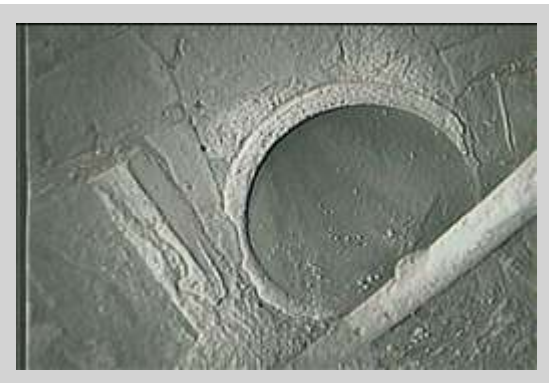
6 in. Circular Gravity Sewer Pipe In @ 3 O'Clock

Pipe Material: **Clay** ☐ Pipe Lined

Invert Depth: **8.01** (ft.) Flow Characteristics: **None**

Deposits: ☒ **None** ☐ Mud ☐ Sludge ☐ Debris ☐ Grease

Infiltration: **None**

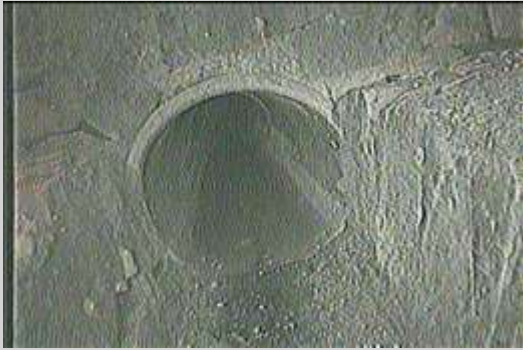
8 in. Circular Gravity Sewer

Pipe Material: **Clay** ☐ Pipe Lined

Infiltration: **None** Pipe Seal Cond: **Unknown**
